SERVICE INFORMATION	12-1
TROUBLESHOOTING	12-2
TRANSMISSION DISASSEMBLY	12-3
SHIFT FORK AND SHIFT DRUM	12-5
TRANSMISSION ASSEMBLY	12-8

TRANSMISSION DISASSEMBLY

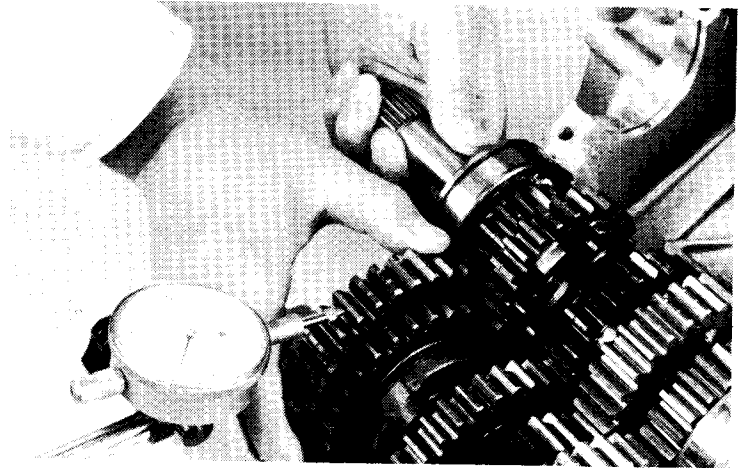
Separate the crankcase (Section 11).
Inspect each gear for backlash.

SERVICE LIMIT: 0.15 mm (0.006 in)

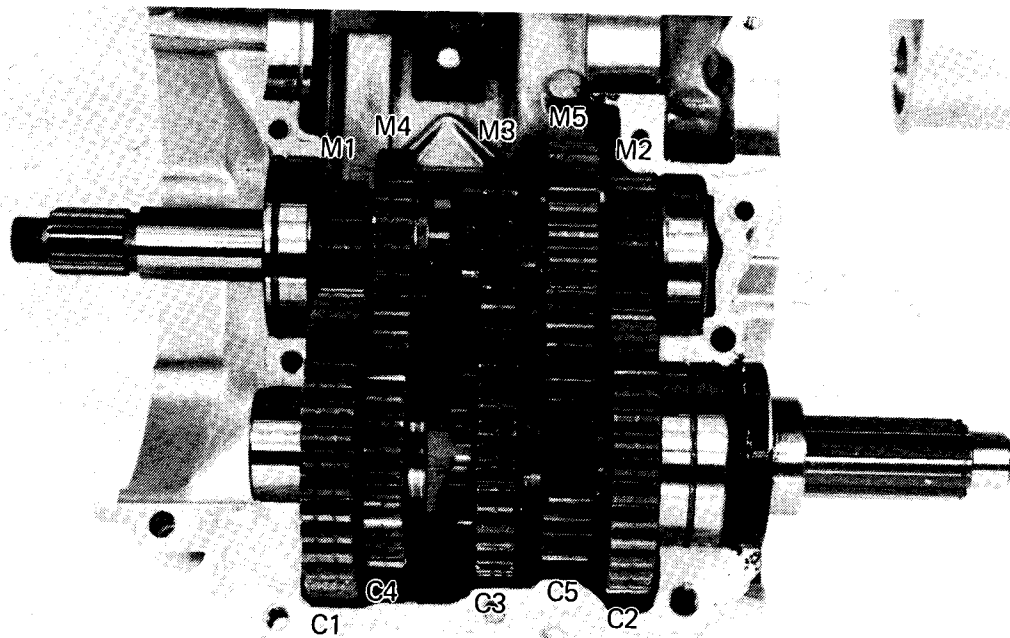
Remove the mainshaft and countershaft.
Remove the dowel pins from the crankcase.

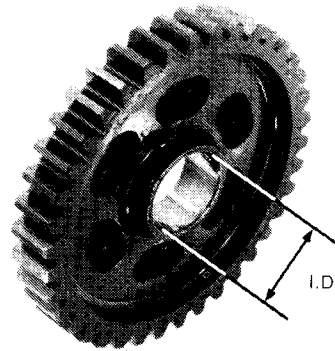
Measure the I.D. of each gear.

SERVICE LIMITS:

- M4 gear: 28.06 mm (1.105 in)
- M5 gear: 31.07 mm (1.113 in)
- C1 gear: 25.06 mm (0.987 in)
- C3 gear: 28.07 mm (1.105 in)

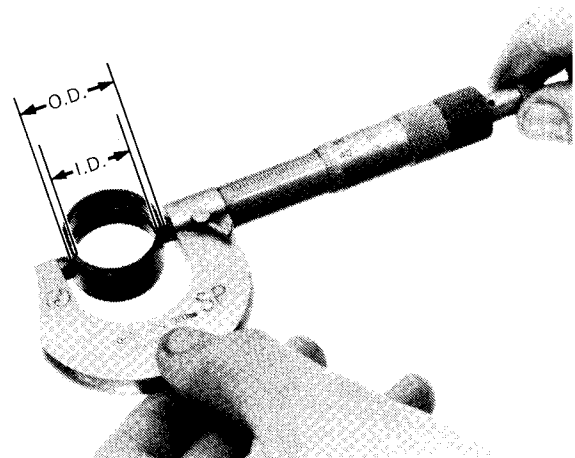
Measure the I.D. and O.D. of the gear bushings.

SERVICE LIMITS:

- M5 O.D.: 30.93 mm (1.218 in)
- C1 O.D.: 24.93 mm (0.981 in)
- C1 I.D.: 22.06 mm (0.869 in)

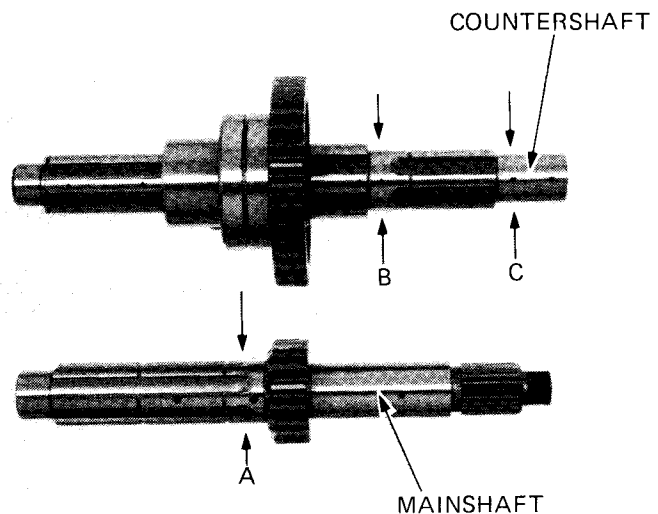
Measure the O.D. of the mainshaft and countershaft.

SERVICE LIMITS:

- A (at M4 gear) : 27.930 mm (1.0996 in)
- B (at C3 gear) : 27.941 mm (1.1000 in)
- C (at C1 bushing) : 21.930 mm (0.8634 in)

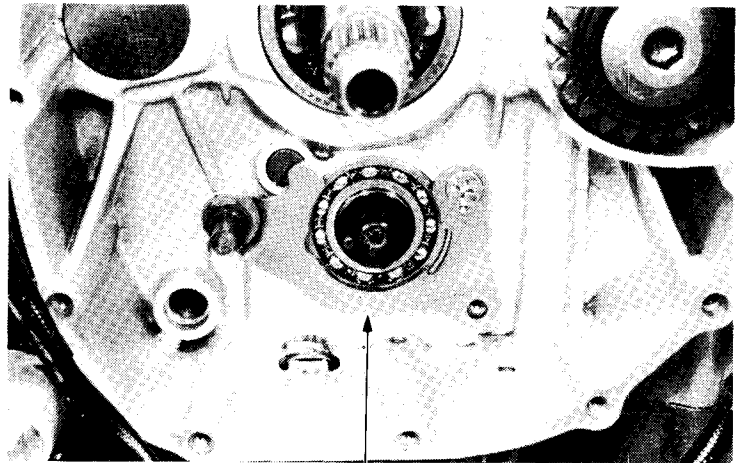
BEARING STOPPER PLATE

Remove the bearing stopper plate.

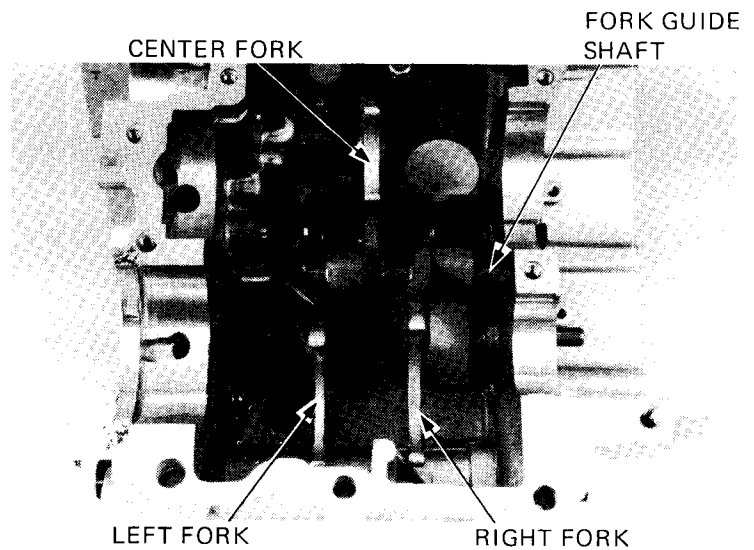
Remove the shift fork shaft and shift forks.
Remove the shift drum.

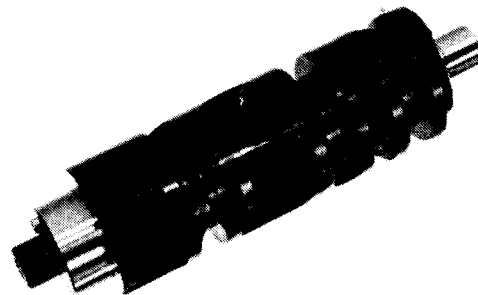
Inspect the shift drum end for scoring, scratches, or evidence of insufficient lubrication.

Check the shift drum grooves for damage.

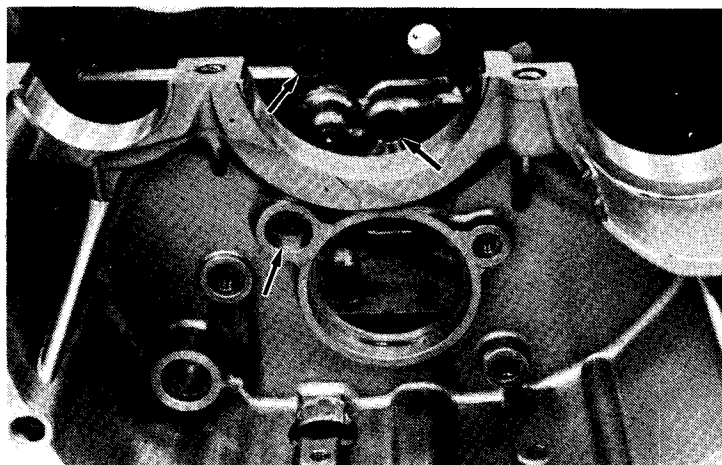
Inspect the shift drum hole and shift fork shaft hole for scoring or scratches.

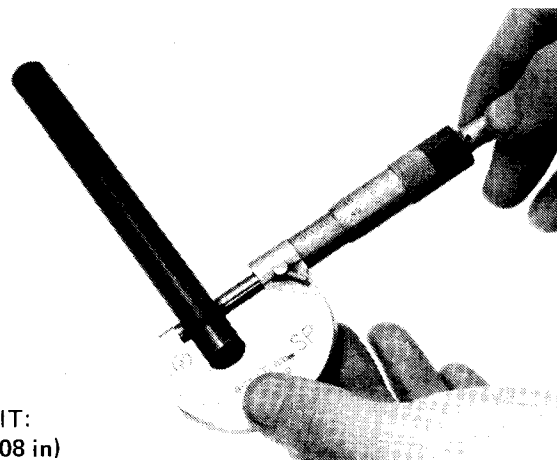
Measure the shift fork shaft O.D.
Check for scratches, scoring, or evidence of insufficient lubrication.

SERVICE LIMIT:
12.90 mm (0.508 in)

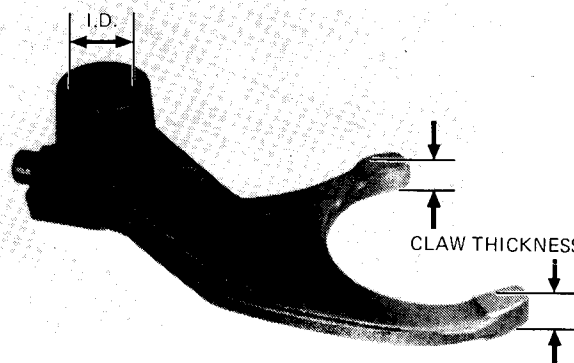
Measure the shift fork I.D. and claw thickness.

SERVICE LIMITS:

I.D.: 13.04 mm (0.513 in)
CLAW THICKNESS: 6.1 mm (0.24 in)

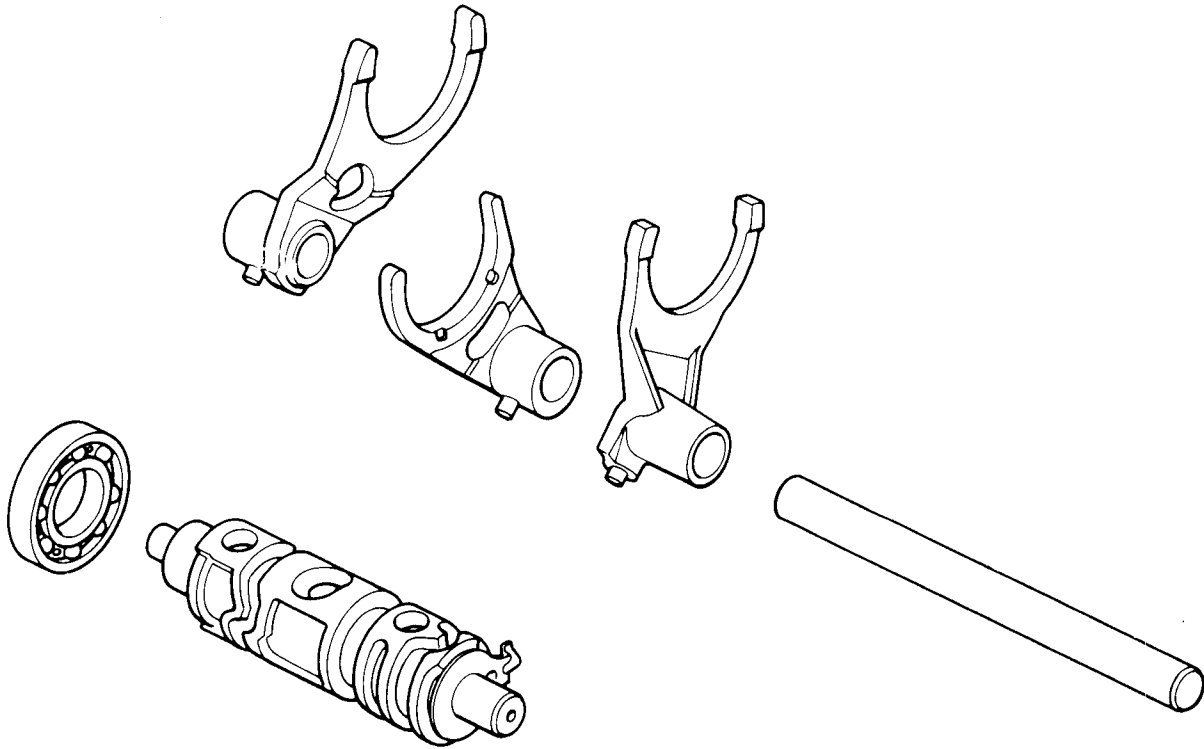
Install the shift drum and shift fork, by reversing the removal procedure. Key points are shown here.

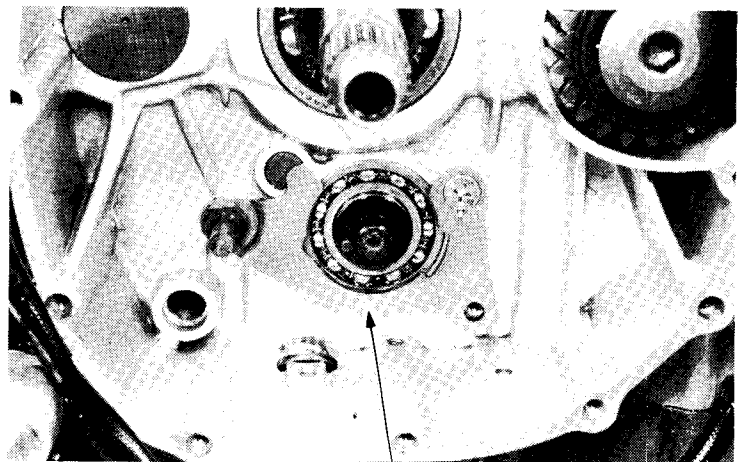
BEARING STOPPER PLATE

When installing the bearing stopper plate, apply a locking agent to the screw threads.

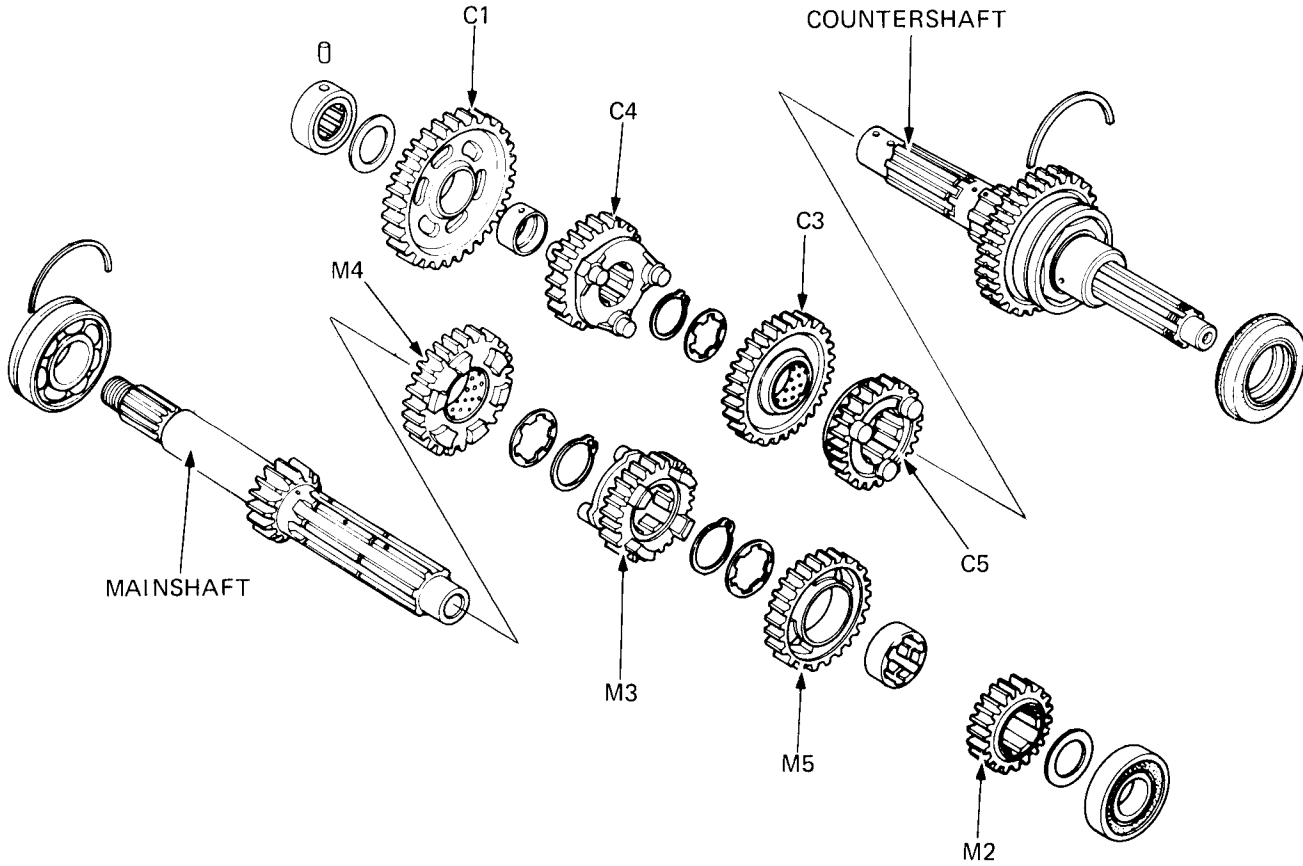
Assemble the mainshaft and countershaft.

- Check the gears for freedom of movement or rotation on the shaft.
- Check that the snap rings are seated in the grooves.

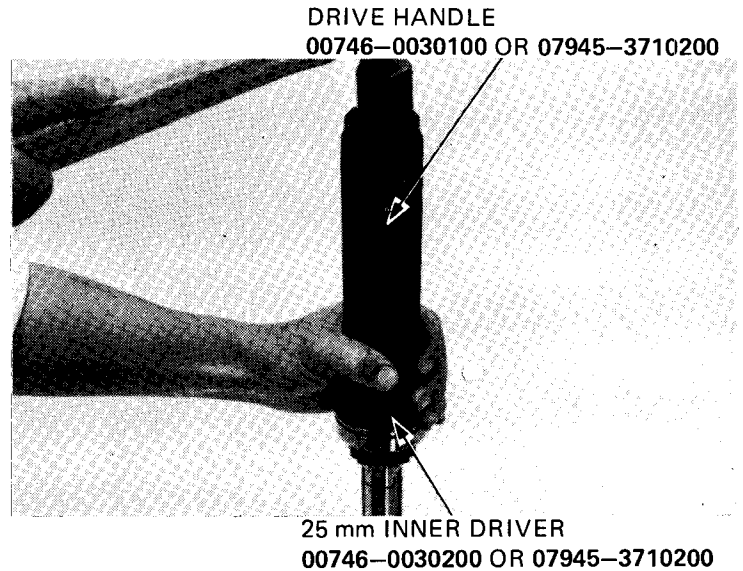
Install the mainshaft bearing with tools.

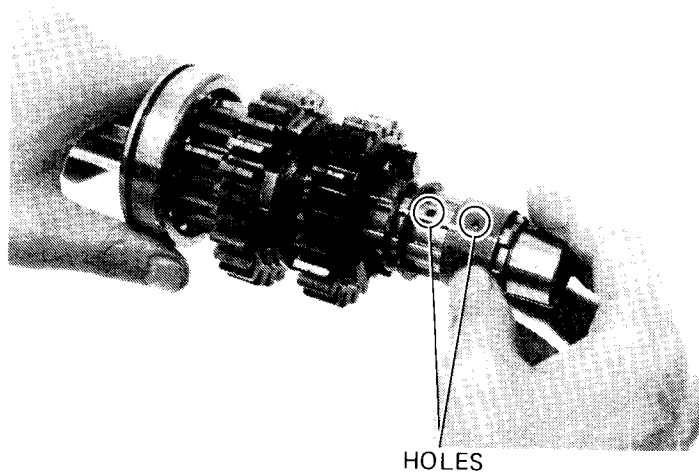
Align the hole in the M5 gear bushing with the hole in the mainshaft.

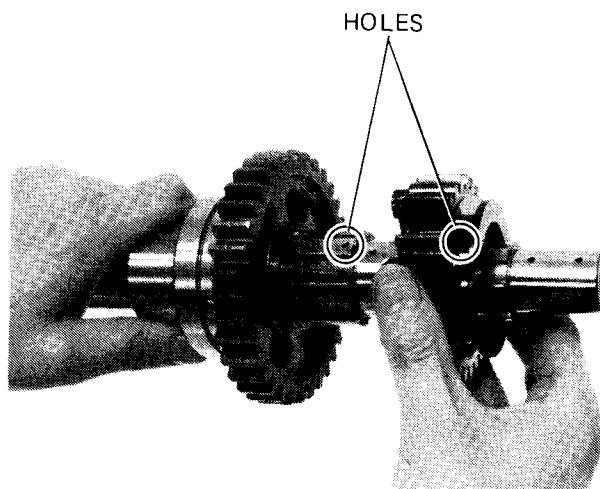
Align the hole in the C5 gear with the hole in the countershaft.

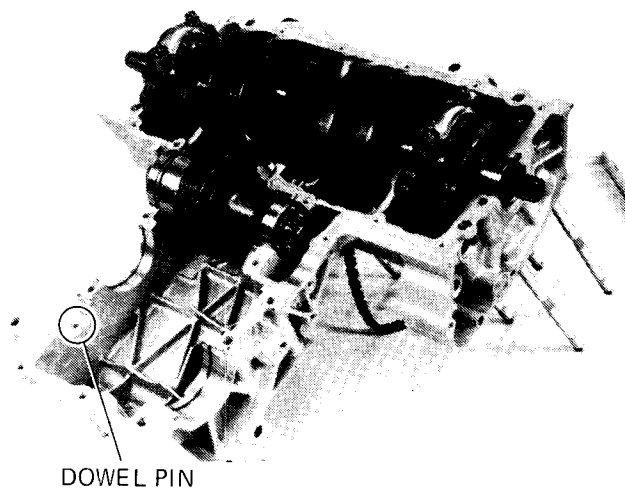
Insert the dowel pin.

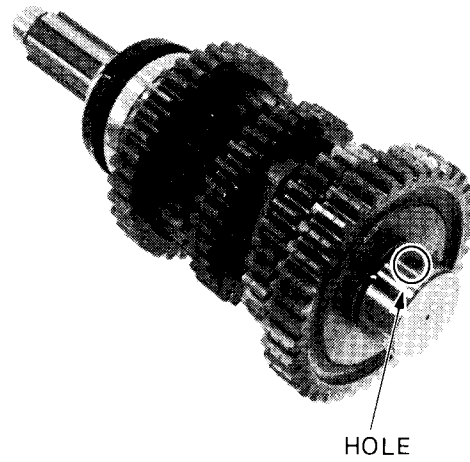
Align the hole in the countershaft bearing with the dowel pin.

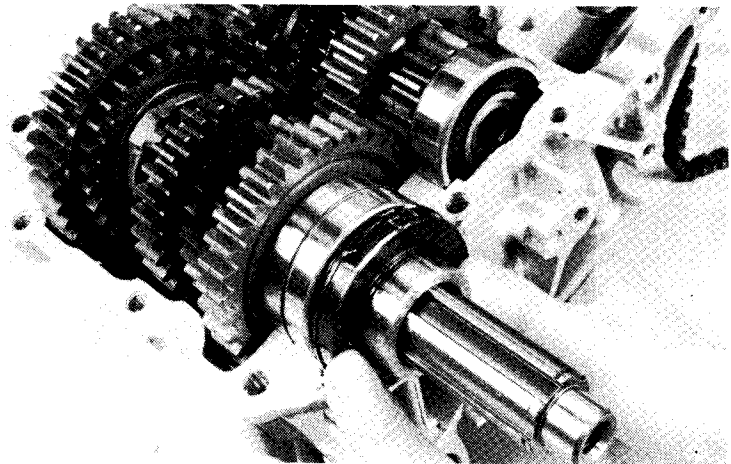
Push the countershaft oil seal in until the oil seal lip is seated completely on the bearing before assembling the lower crankcase to prevent oil leakage.

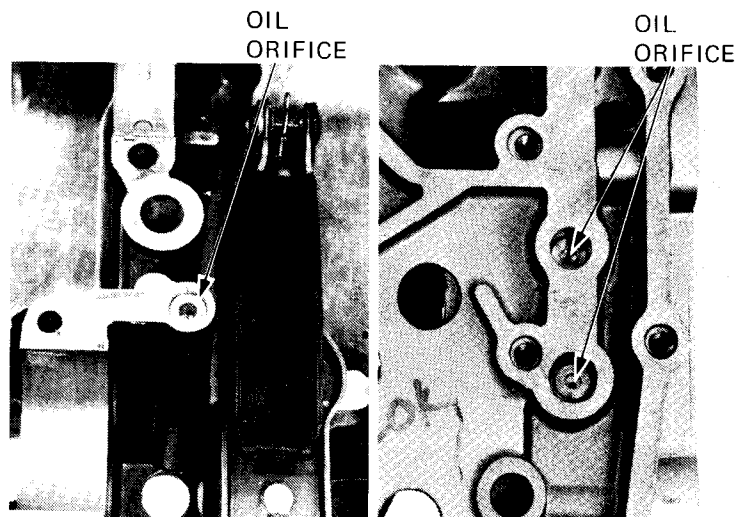
Install the lower crankcase (Refer to Section 11).

Check the oil orifice for clogging, before installing the lower crankcase.
